**Flood Control Project Maintenance  
Levee Inspections**

**Fall 2011 Levee Maintenance Deficiency Summary Report**

**Sacramento River Basin**

**Reclamation District No. 0150 Merrit Island**

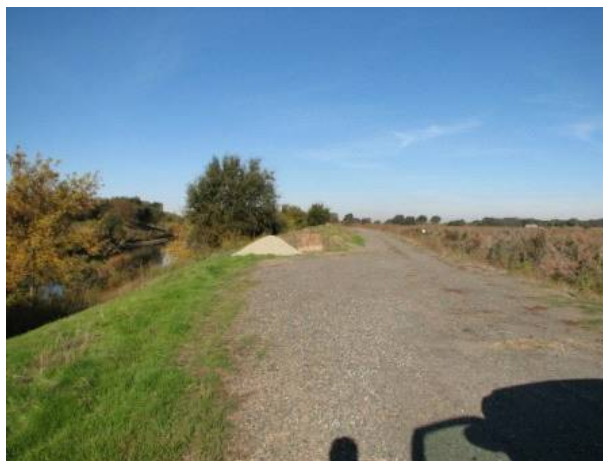
pkazi\_f\_20110923\_275.jpg

View of a hay bale target on the crown of the levee looking west.

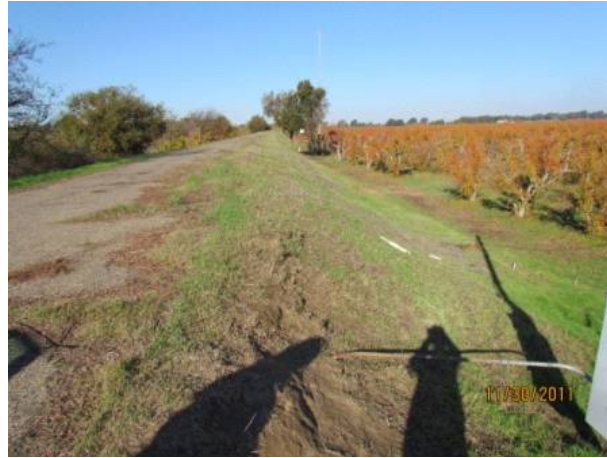
pkazi\_f\_20111208\_445.jpg

Vegetation was mowed by the LMA on the landside of the levee looking upstream.

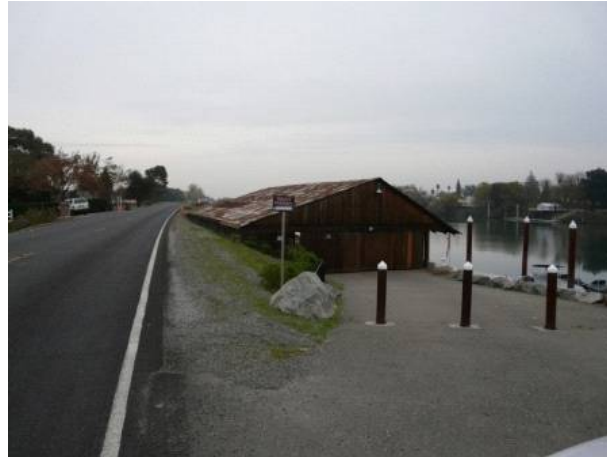
pkazi\_f\_20110923\_295.JPG

Building located on waterside of levee at LM 0.16

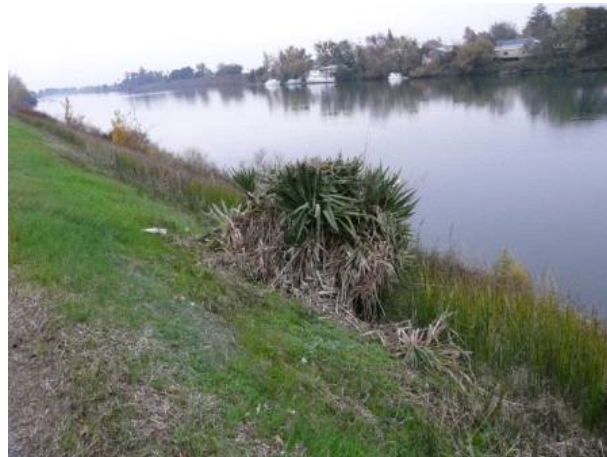
pkazi\_f\_20110923\_296.JPG

Levee Mile Report Line	3
Start Levee Mile	0.24
End Levee Mile	0.24
Location	Water Side
Category	Earthen Levee
Item	Vegetation

Remove century plant within 20' of waterside shoulder on waterside of the levee at LM 0.24

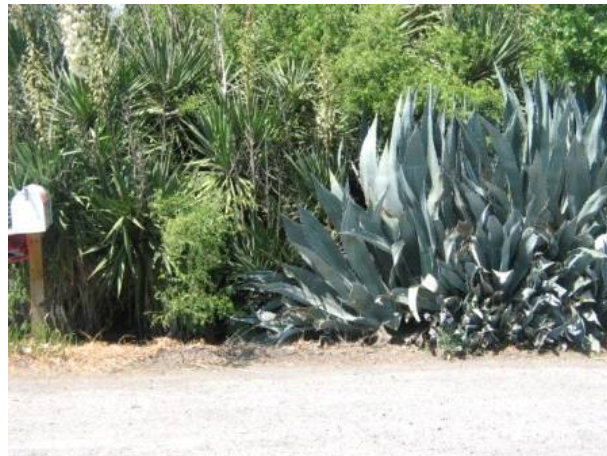
pkazi\_f\_20110923\_278.jpg

Levee Mile Report Line	4
Start Levee Mile	0.25
End Levee Mile	0.25
Location	Land Side
Category	Earthen Levee
Item	Encroachments

Landscaping on landward slope at LM 0.25 blocking view of levee slope.

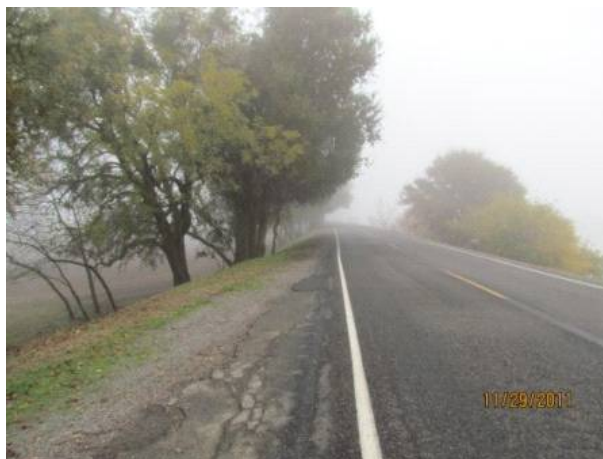
pkazi\_f\_20111208\_436.jpg

Tree were trimmed on the landside of the levee looking upstream.

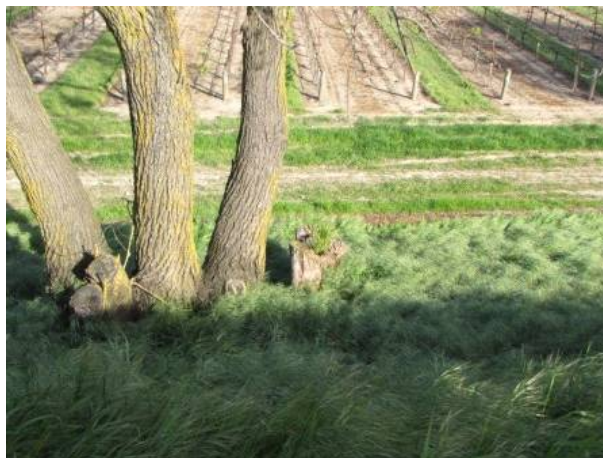
pkazi\_f\_20110923\_280.jpg

Levee Mile Report Line	18
Start Levee Mile	1.16
End Levee Mile	1.16
Location	Land Side
Category	Earthen Levee
Item	Trim / Thin Trees

View of a tree stump on the landward slope.

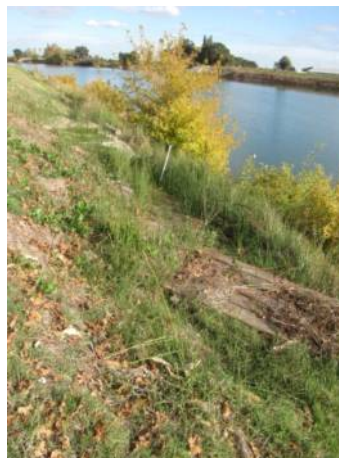
pkazi\_f\_20110923\_310.jpg

View of debris located on the waterward slope looking upstream.

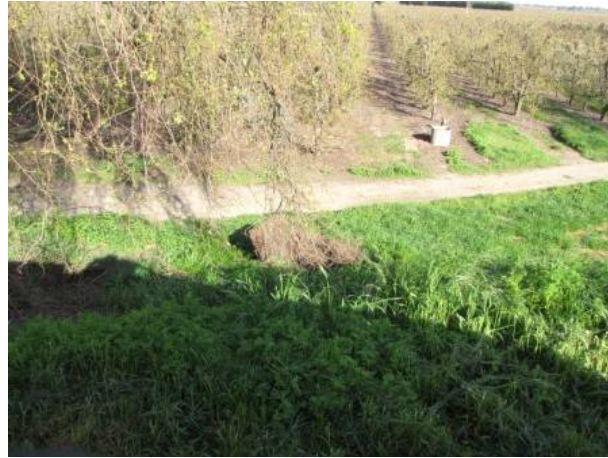
pkazi\_f\_20110923\_282.jpg

View of a tree stump on the landward slope.

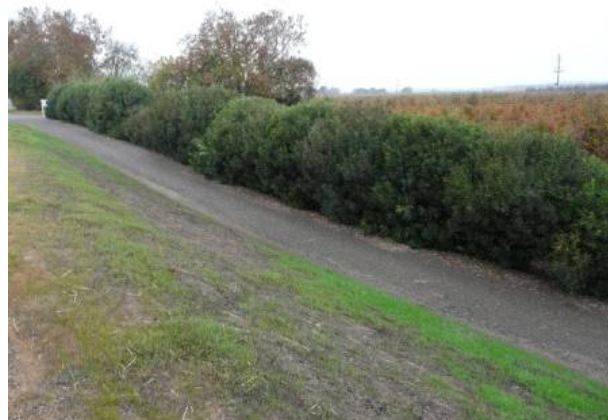
pkazi\_f\_20110923\_306.JPG

Landscaping providing a screen for a residence on landside of levee from LM 3.02 to LM 3.06

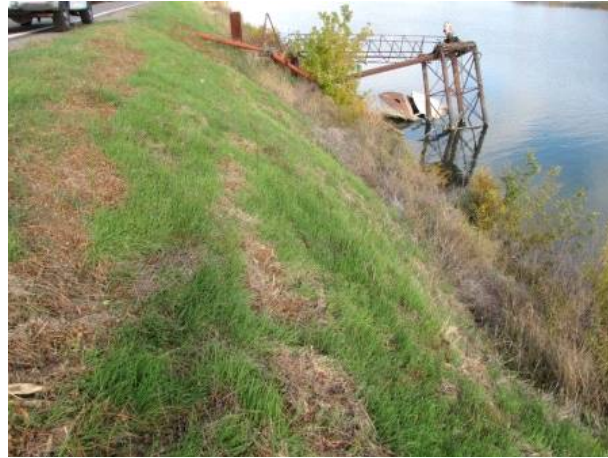
pkazi\_f\_20110923\_311.jpg

View of erosion on the waterward slope looking upstream. Depressions into the slope can be seen in several places.

LMR No.	Levee Mile		Category	Item	Location	Rating	Action/Comment	GPS Latitude/Longitude		Issue No. Photo
	Start	End						Start	End	
36	3.29	3.29	Earthen Levee	Erosion / Bank Caving	WS	M	Schedule repair of erosion site prior to the next inspection. Inspector Comments: Depressions into the waterward slope can be seen along the waterward slope at this site. Also note the damaged pump support, pump, and pipe just upstream of the site; they may contribute to the erosion in a high water event and should be removed.	38.355321 ° -121.530902 °	38.355321 ° -121.530902 °	961 Y
37	3.31	3.31	Earthen Levee	Trim / Thin Trees	LS	A	Thin trees to allow visibility of the ground and room to flood fight.	38.355632 ° -121.530740 °	38.355632 ° -121.530740 °	952 Y
38	3.35	3.35	Earthen Levee	Vegetation	LS	M	Elderberries are blocking visibility and flood fight capability.	38.355979 ° -121.530288 °	38.355979 ° -121.530288 °	17

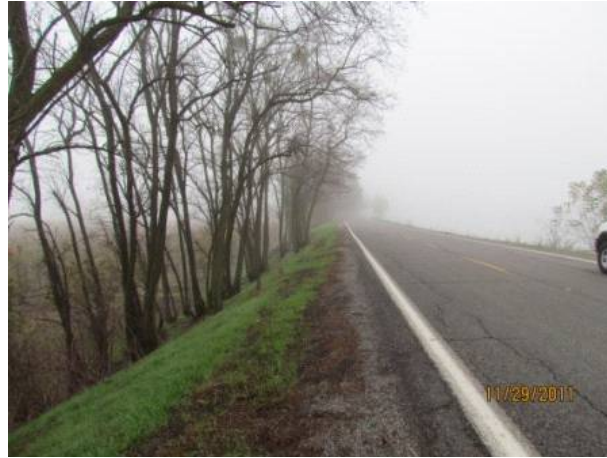
pkazi\_f\_20111208\_439.jpg

Trees were trimmed by the LMA on the landside of the levee looking upstream.

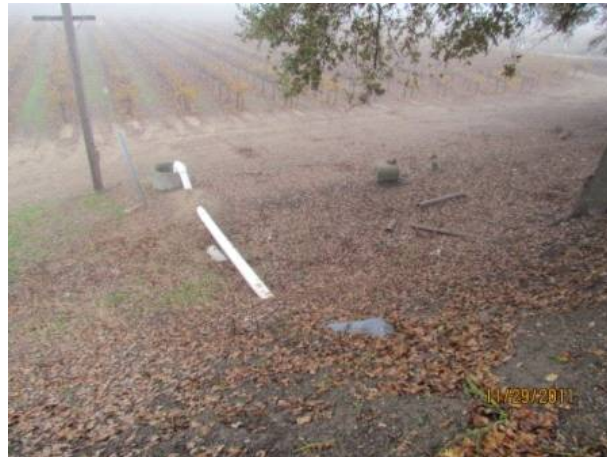
pkazi\_f\_20111208\_440.jpg

Levee Mile Report Line	40
Start Levee Mile	3.56
End Levee Mile	3.56
Location	Crown
Category	Earthen Levee
Item	Encroachments

PVC pipe was used under the levee crown for irrigation purpose. The picture was taken from the crown looking downstream.

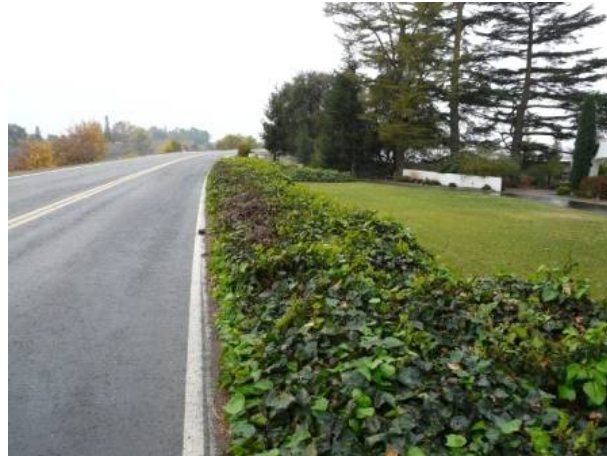
pkazi\_f\_20110923\_305.JPG

Levee Mile Report Line	42
Start Levee Mile	3.90
End Levee Mile	3.93
Location	Land Side
Category	Earthen Levee
Item	Encroachments

Landscaping in front of a residence on landside of levee from LM 3.90 to LM 3.93. The levee in this location is greater than 100' wide.

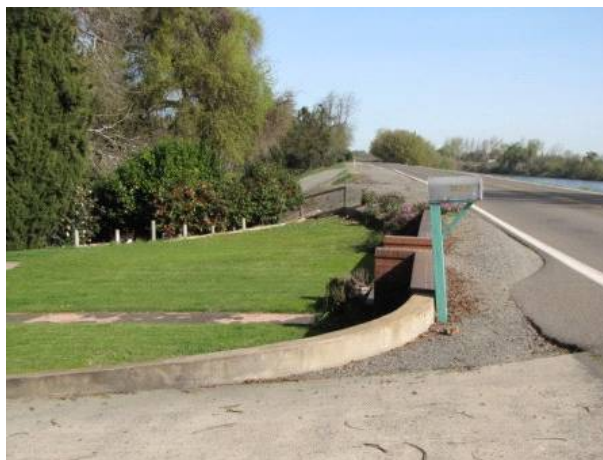
pkazi\_f\_20110923\_283.jpg

View of a retaining wall on the landward slope looking upstream.

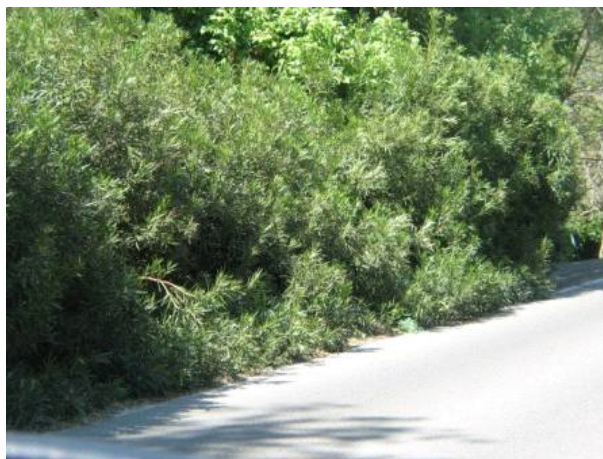
pkazi\_f\_20110923\_284.jpg

Levee Mile Report Line	45
Start Levee Mile	4.33
End Levee Mile	4.35
Location	Land Side
Category	Earthen Levee
Item	Encroachments

Landscaping (Oleander) on landward slope from 4.33 to 4.35

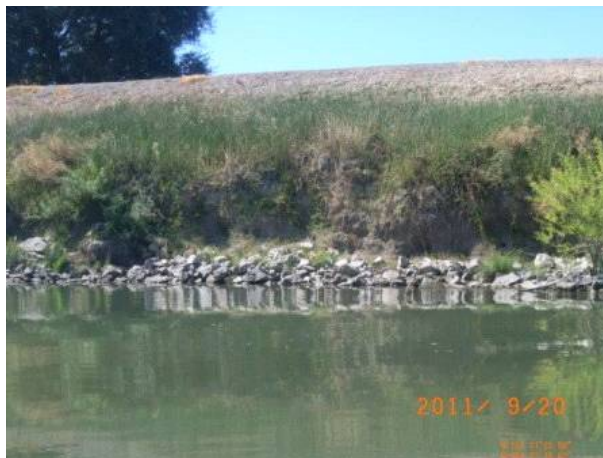
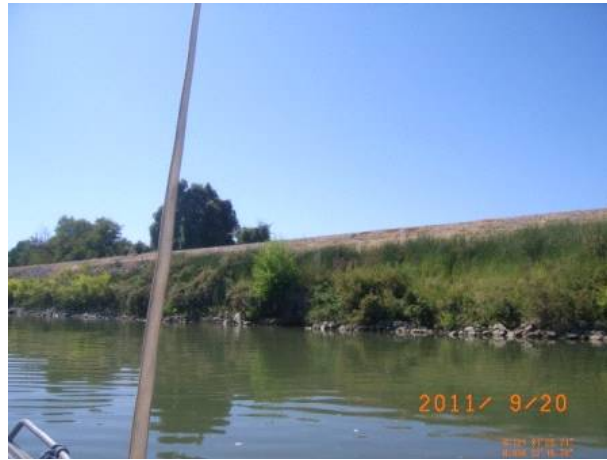
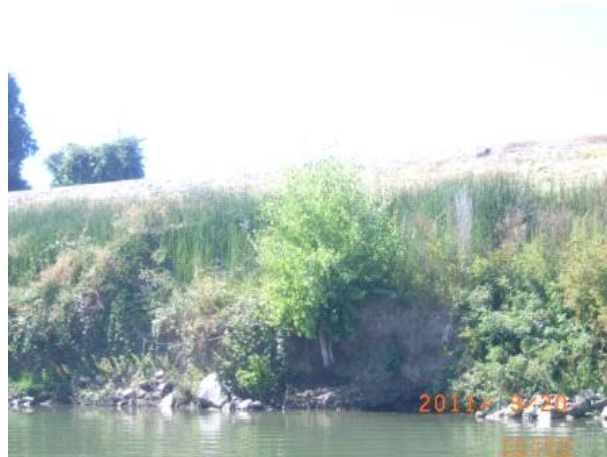
46	4.37	4.41	Earthen Levee	Encroachments	LS	CO	Landscaping	38.368036 ° -121.522611 °	38.368540 ° -121.522729 °	79
47	4.47	4.47	Supplemental	USACE Erosion Survey	WS	M	Inspector Comments: 1999 - Downstream end (300 ft) repaired with rock. 2010 - Toe erosion, some vertical slopes lower down. 2011: Failing rock repair. Slumping of the lower bank. Minor new erosion. [2011 Site ID: SAC_38-5_R]	38.370928 ° -121.523069 °	38.371909 ° -121.523316 °	19 Y
48	4.53	4.68	Earthen Levee	Vegetation	LS	C	Remove the wild growth other than native grasses from the levee slopes.	38.370322 ° -121.523120 °	38.372337 ° -121.523748 °	42
49	4.68	4.68	Earthen Levee	Trim / Thin Trees	LS	M	Thin trees to allow visibility of the ground and room to flood fight.	38.372380 ° -121.523802 °	38.372380 ° -121.523802 °	977 Y
50	4.76	4.76	Earthen Levee	Vegetation	WS	M	Remove the wild growth other than native grasses from the levee slopes.	38.373485 ° -121.523963 °	38.373485 ° -121.523963 °	28 Y

Levee Mile Report Line	47
Start Levee Mile	4.47
End Levee Mile	4.47
Location	Water Side
Category	Supplemental
Item	USACE Erosion Survey

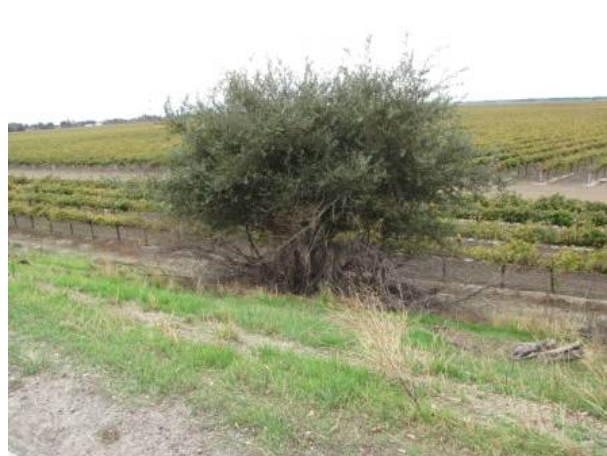
pkazi\_f\_20110923\_317.jpg

Levee Mile Report Line	49
Start Levee Mile	4.68
End Levee Mile	4.68
Location	Land Side
Category	Earthen Levee
Item	Trim / Thin Trees

View of a tree on the landward slope with lower branches blocking visibility and access. Most of these branches appear to already be dead and should be removed.

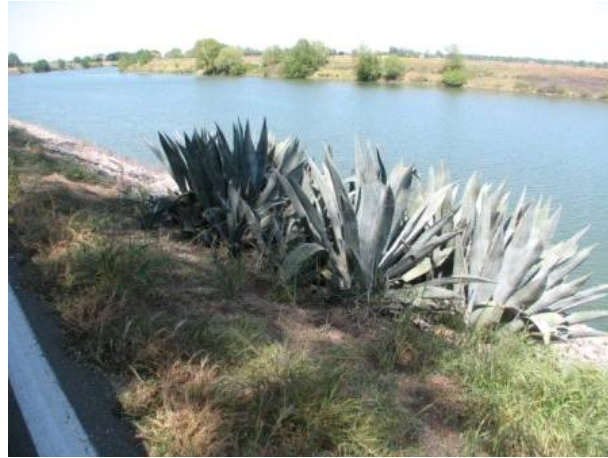
pkazi\_f\_20110923\_285.jpg

Century plant on waterward slope at LM 4.76

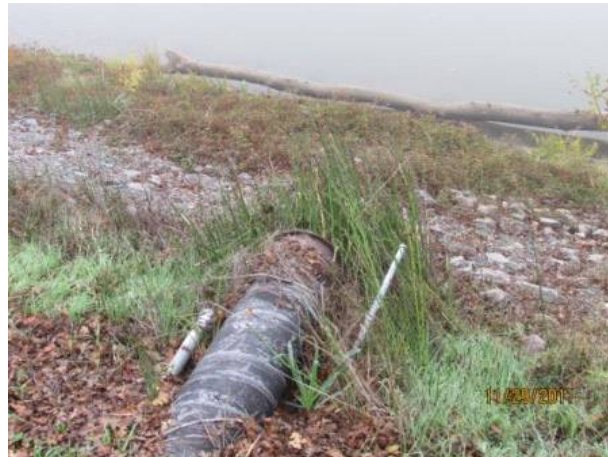
pkazi\_f\_20111208\_441.jpg

Levee Mile Report Line	52
Start Levee Mile	4.95
End Levee Mile	4.95
Location	Water Side
Category	Earthen Levee
Item	Encroachments

End of the pipe was not welded properly to perform as a closure device. The picture was taken from the crown looking upstream.

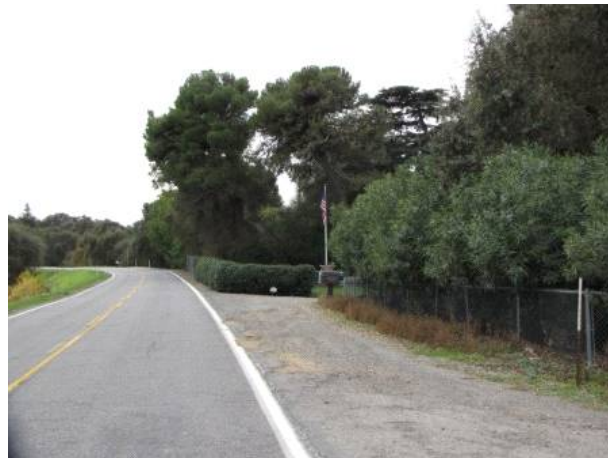
pkazi\_f\_20110923\_304.jpg

Levee Mile Report Line	55
Start Levee Mile	5.17
End Levee Mile	5.22
Location	Land Side
Category	Earthen Levee
Item	Encroachments

View of landscaping along the landward shoulder and slope looking downstream.

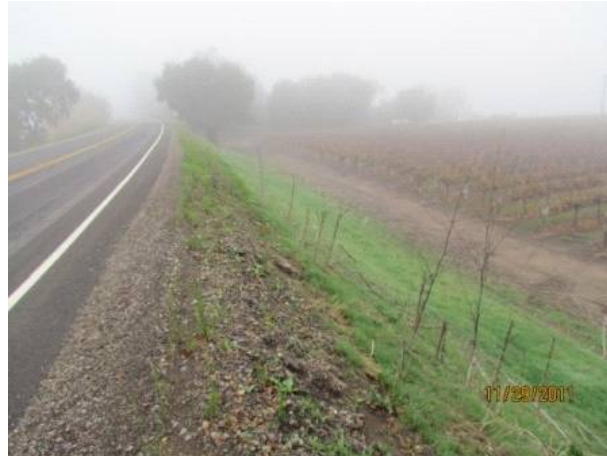
pkazi\_f\_20111208\_442.jpg

Vegetation was mowed by the LMA on the landside of the levee looking downstream.

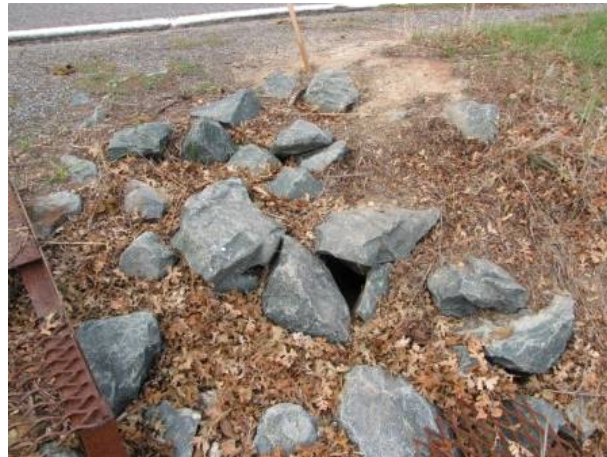
pkazi\_f\_20110923\_316.jpg

Levee Mile Report Line	58
Start Levee Mile	5.33
End Levee Mile	5.33
Location	Water Side
Category	Earthen Levee
Item	Slope Stability

View of rock placed on a pipe penetration on the waterward slope. Cavities can be seen under the rocks.

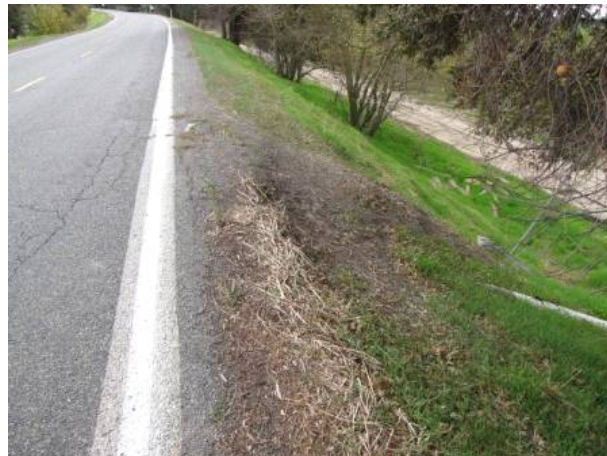
pkazi\_f\_20110923\_315.jpg

Levee Mile Report Line	59
Start Levee Mile	5.33
End Levee Mile	5.33
Location	Land Side
Category	Earthen Levee
Item	Slope Stability

View of a minor depression along the landward slope of the levee over a pipe penetration looking downstream.

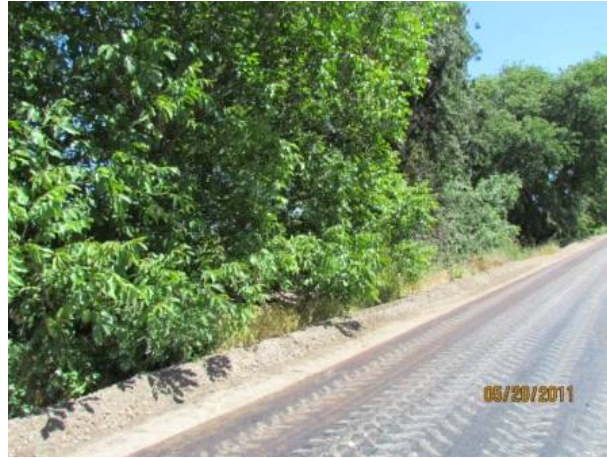
pkazi\_f\_20110923\_291.jpg

Tree branches were obstruction the visibility of the landside slope of the levee. The picture was taken from the crown looking upstream.

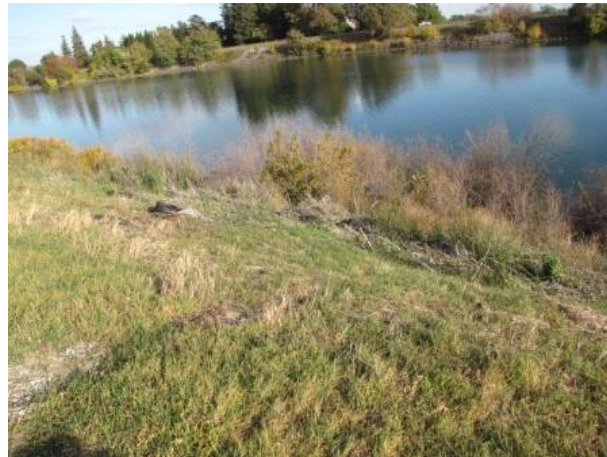
pkazi\_f\_20110923\_313.jpg

Levee Mile Report Line	64
Start Levee Mile	5.81
End Levee Mile	5.81
Location	Water Side
Category	Earthen Levee
Item	Encroachments

View of several tires along the waterward slope.

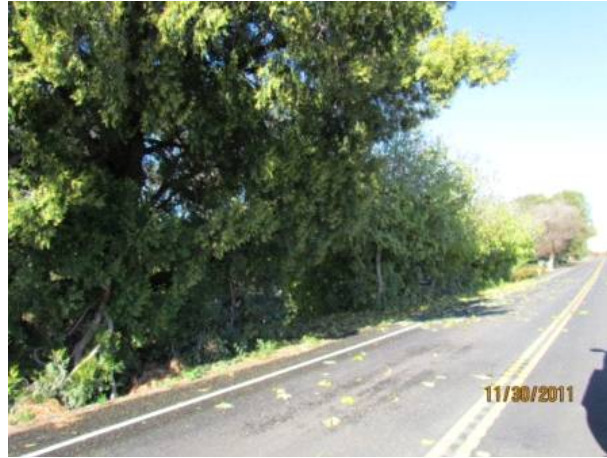
pkazi\_f\_20111208\_447.jpg

Trees need to be trimmed on the landside of the levee looking upstream.

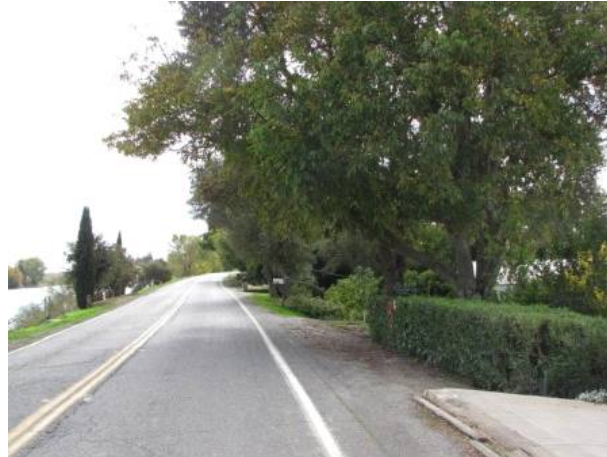
pkazi\_f\_20110923\_303.jpg

Levee Mile Report Line	72
Start Levee Mile	6.50
End Levee Mile	6.57
Location	Land Side
Category	Earthen Levee
Item	Encroachments

View of landscaping along the waterward shoulder and slope looking downstream.

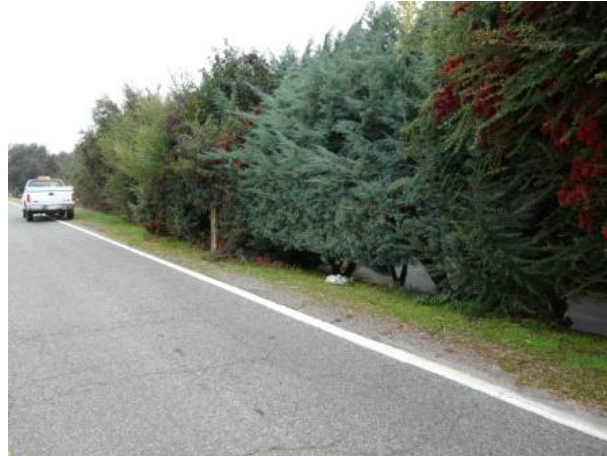
Levee Mile Report Line	75
Start Levee Mile	6.67
End Levee Mile	6.72
Location	Land Side
Category	Earthen Levee
Item	Encroachments
Landscaping providing a screen for a residence on landside of levee from LM 6.68 to LM 6.72	
pkazi_f_20110923_302.JPG

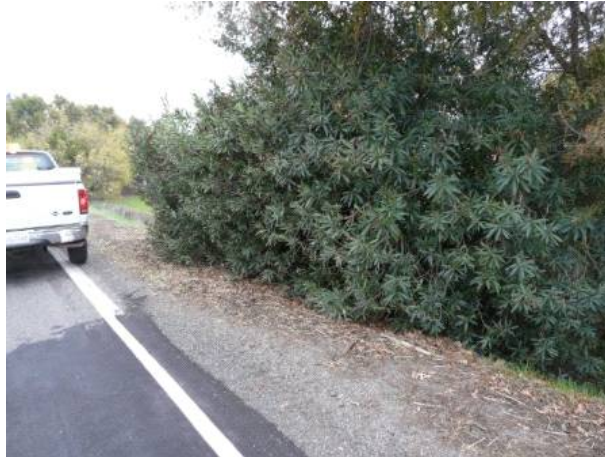
pkazi\_f\_20110923\_300.JPG

Landscaping providing a screen for a residence on landside of levee at LM 7.12

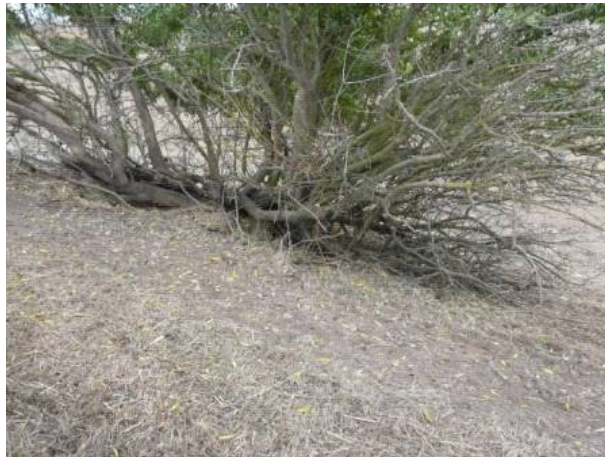
pkazi\_f\_20110923\_292.JPG

Levee Mile Report Line	82
Start Levee Mile	7.25
End Levee Mile	7.25
Location	Land Side
Category	Earthen Levee
Item	Trim / Thin Trees

Trim or remove brush to allow for visibility on landside of levee at LM 7.25

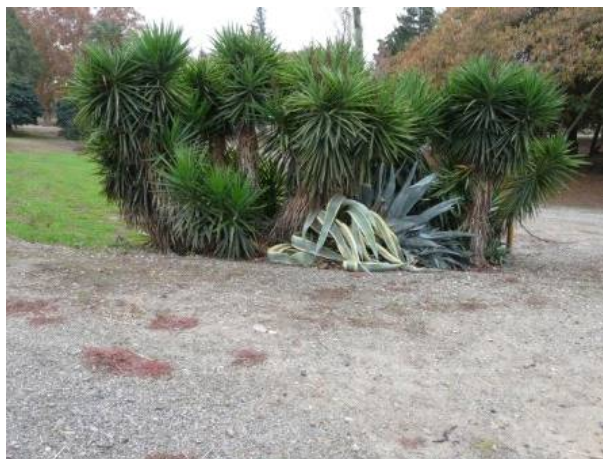
pkazi\_f\_20110923\_299.JPG

Levee Mile Report Line	87
Start Levee Mile	7.92
End Levee Mile	7.92
Location	Land Side
Category	Earthen Levee
Item	Encroachments

Landscaping on landside of levee at LM 7.92

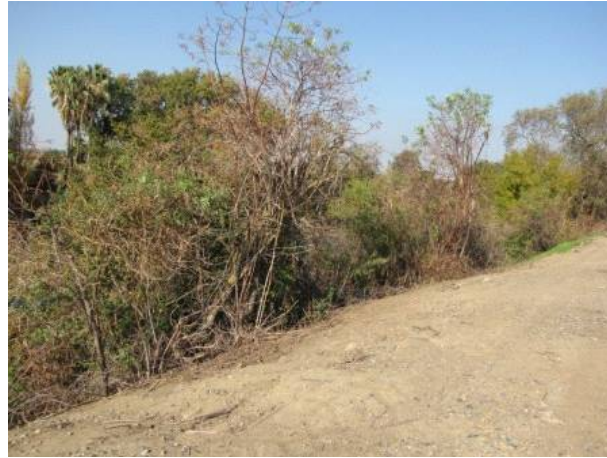
pkazi\_f\_20110923\_383.jpg

View of elderberry bush within 20 feet of shoulder blocking visibility and access.

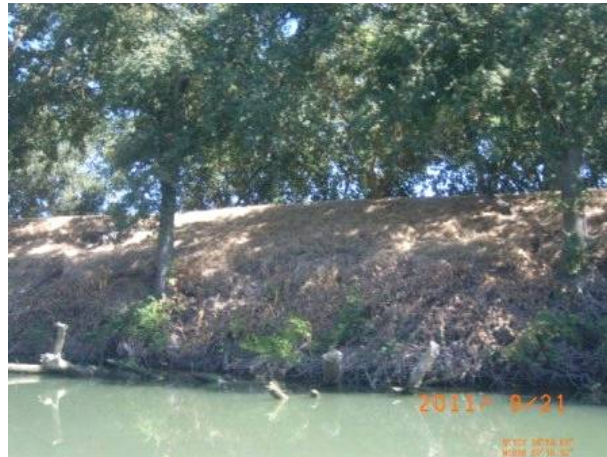
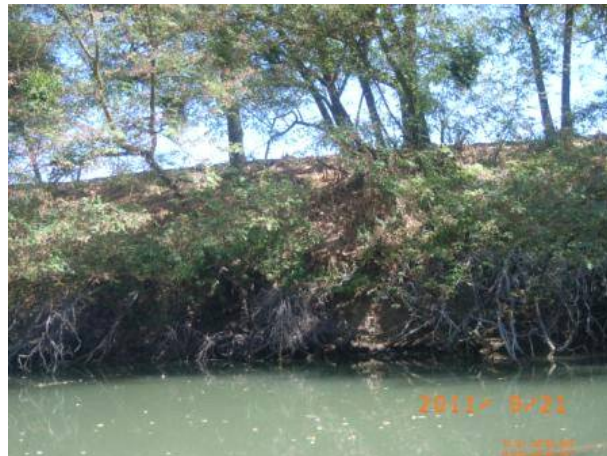
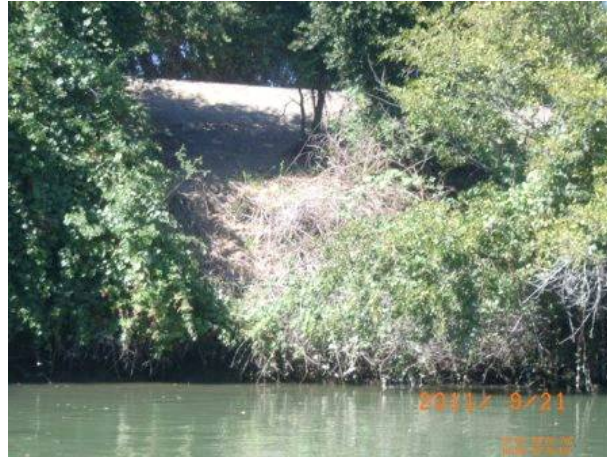
Levee Mile Report Line	2
Start Levee Mile	0.15
End Levee Mile	9.40
Location	Water Side
Category	Supplemental
Item	USACE Erosion Survey

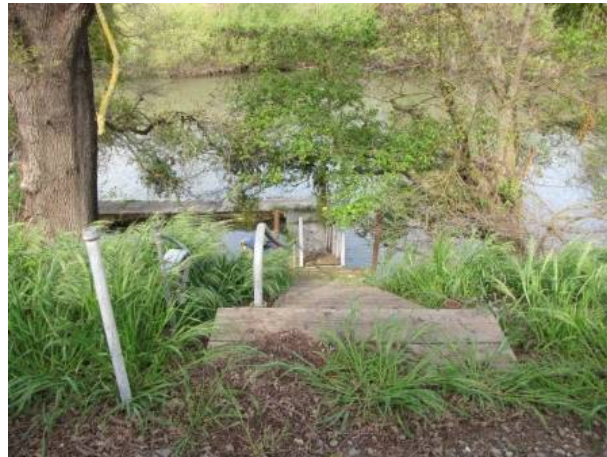
Levee Mile Report Line	3
Start Levee Mile	0.36
End Levee Mile	0.36
Location	Water Side
Category	Earthen Levee
Item	Encroachments

View of steps, a dock, and associated utilities on the waterward slope.

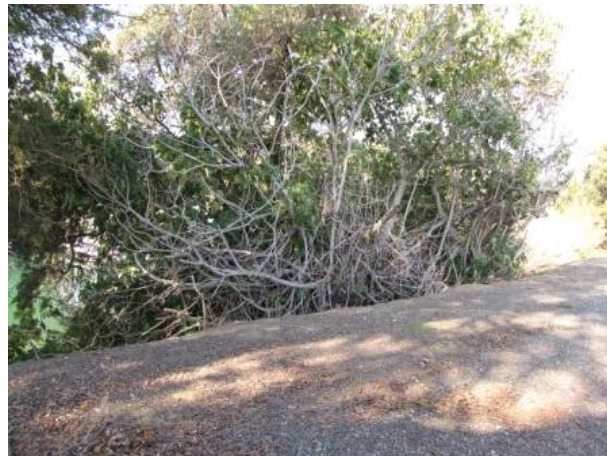
Levee Mile Report Line	6
Start Levee Mile	0.56
End Levee Mile	0.56
Location	Water Side
Category	Earthen Levee
Item	Trim / Thin Trees

View of trees and bushes within 20 feet of the shoulder blocking visibility and access.

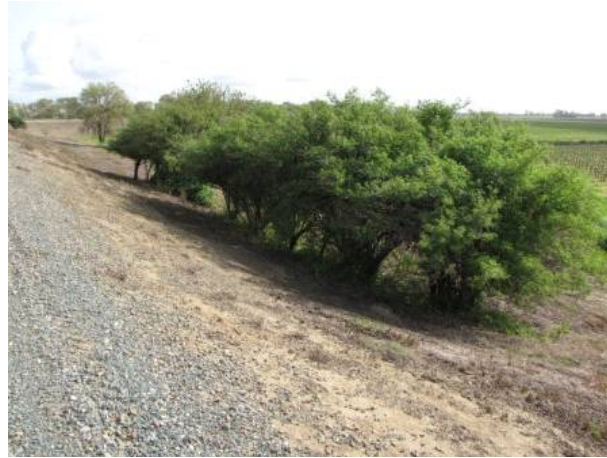
View of elderberries on the landward slope blocking visibility and access.

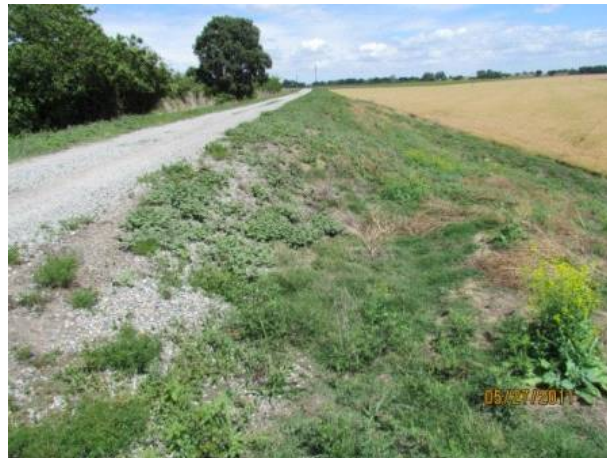
Erosion couldn't be seen due to vegetation during Spring 2011 inspection. The picture was taken from the crown looking upstream.

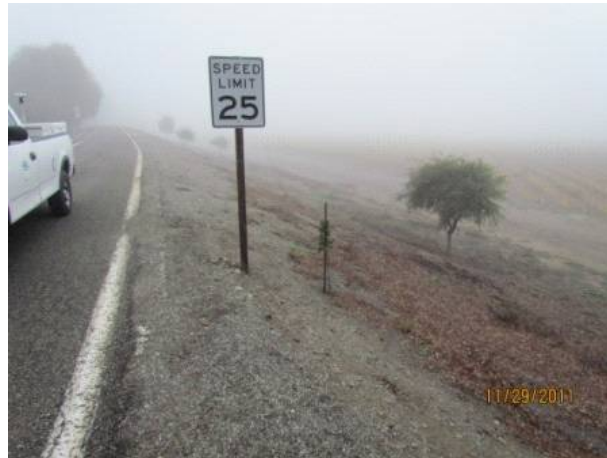
New tree has been planted on the landside slope of the levee looking upstream.

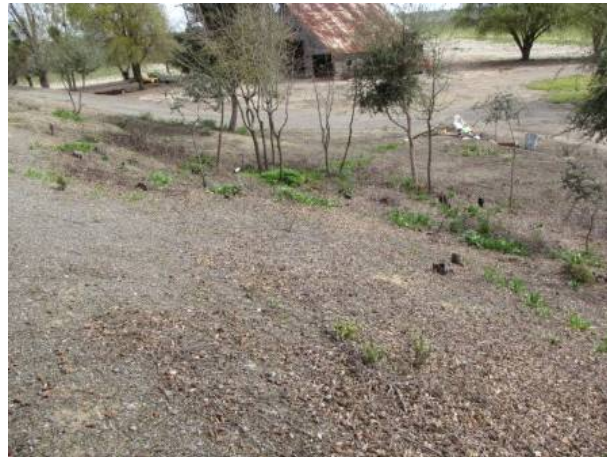
Levee Mile Report Line	15
Start Levee Mile	2.60
End Levee Mile	2.60
Location	Land Side
Category	Earthen Levee
Item	Trim / Thin Trees

View of tree stumps on the landward slope.

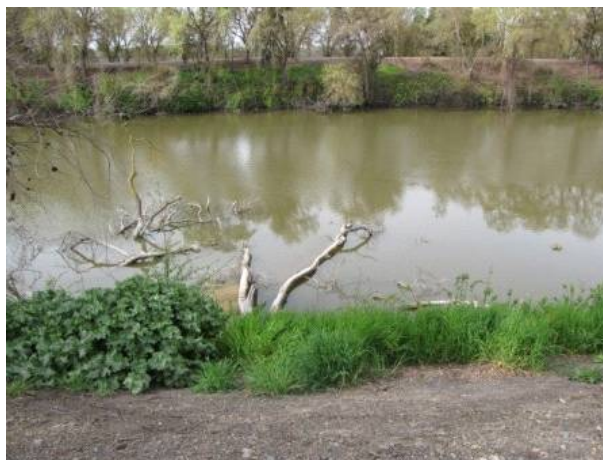
View of tree stumps on the waterward slope.

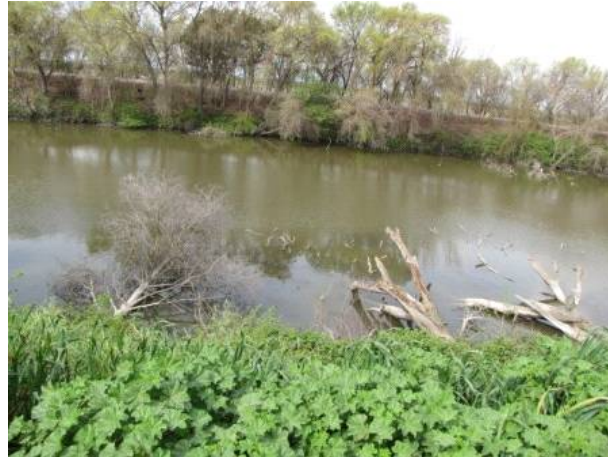
View of tree stumps on the waterward slope.

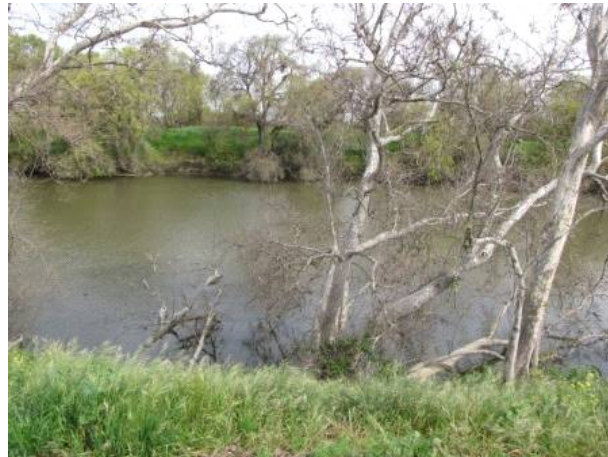
Levee Mile Report Line	21
Start Levee Mile	3.18
End Levee Mile	3.18
Location	Water Side
Category	Earthen Levee
Item	Trim / Thin Trees

View of tree stumps on the waterward slope.

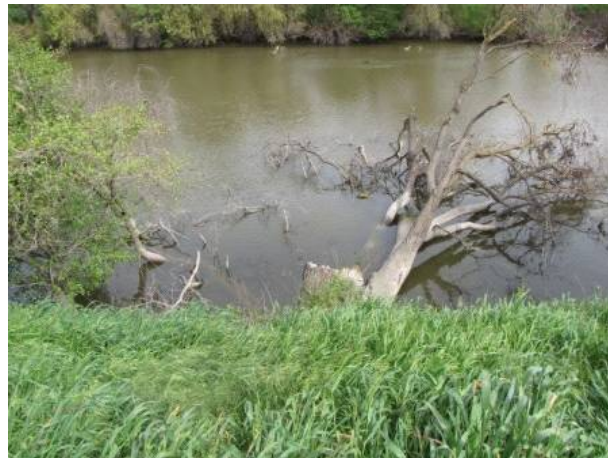
Levee Mile Report Line	22
Start Levee Mile	3.21
End Levee Mile	3.21
Location	Water Side
Category	Earthen Levee
Item	Trim / Thin Trees

View of tree stumps on the waterward slope.

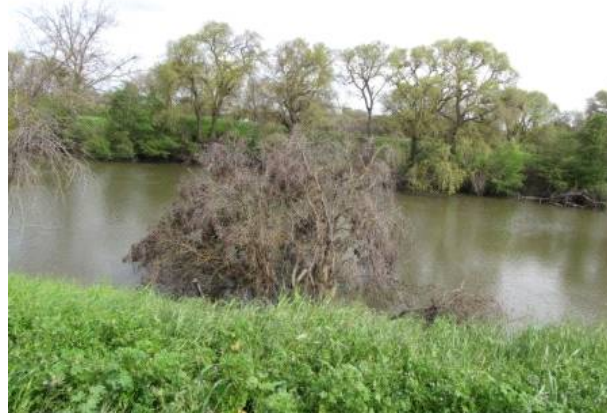
View of tree stumps on the waterward slope.

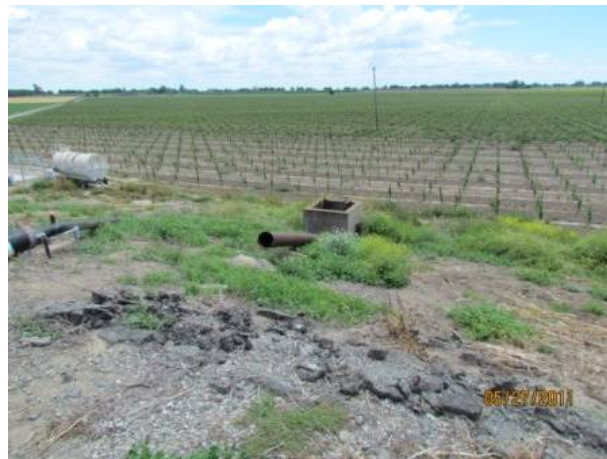
Levee Mile Report Line	27
Start Levee Mile	3.34
End Levee Mile	3.34
Location	Land Side
Category	Earthen Levee
Item	Encroachments
An abandon pipe was located on the landside of the levee. The picture was taken from the crown looking downstream.	
pkazi_f_20110923_350.jpg

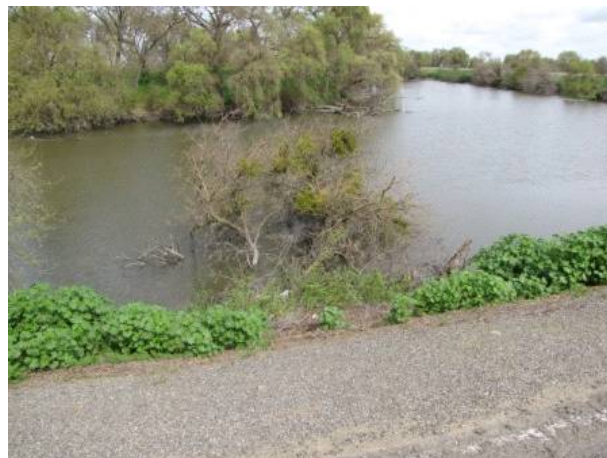
Levee Mile Report Line	28
Start Levee Mile	3.41
End Levee Mile	3.41
Location	Water Side
Category	Earthen Levee
Item	Trim / Thin Trees
View of tree stumps on the waterward slope.	
pkazi_f_20110923_339.jpg

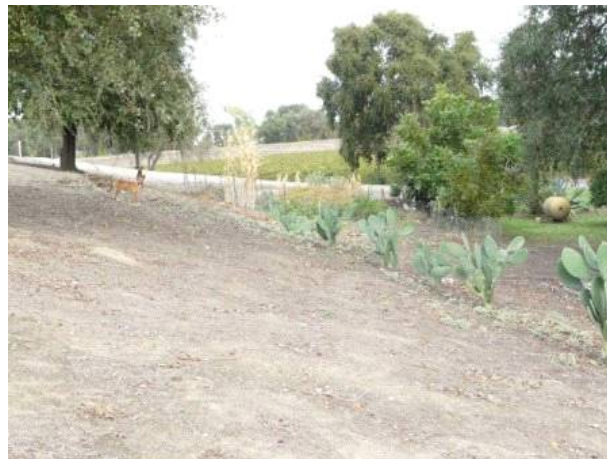
Landscaping & garden on landward slope of levee at LM 3.50 to LM 3.54.

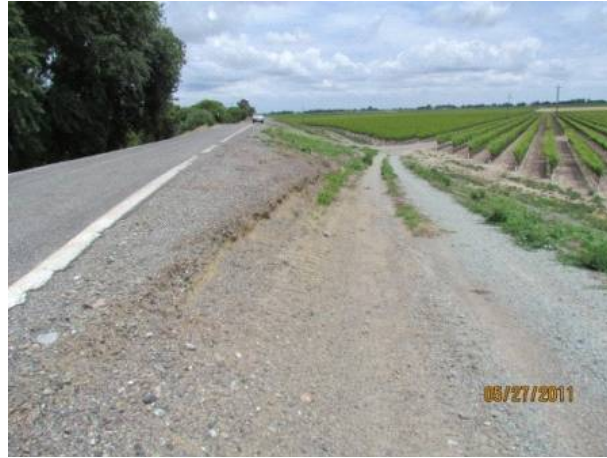
Slope instability possible due to vehicular traffic on the landside of the levee. The picture was taken from the crown looking upstream during Spring 2011 inspection.

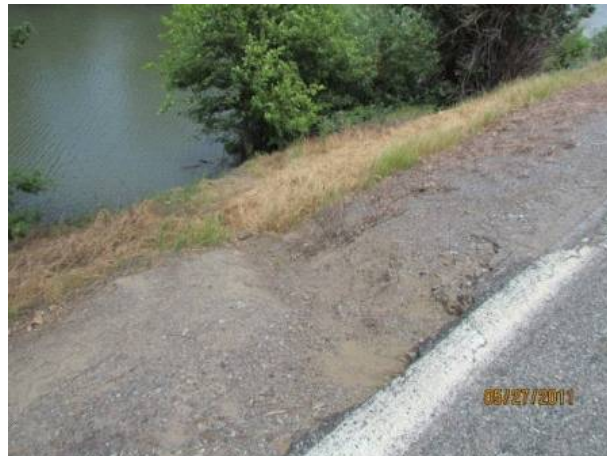
Updated picture of the erosion on the waterside slope of the levee during Spring 2011 inspection.

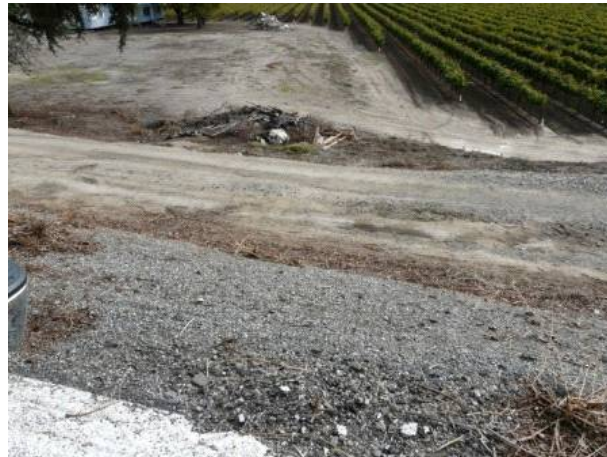
Debris pile on landward slope at LM 3.95.

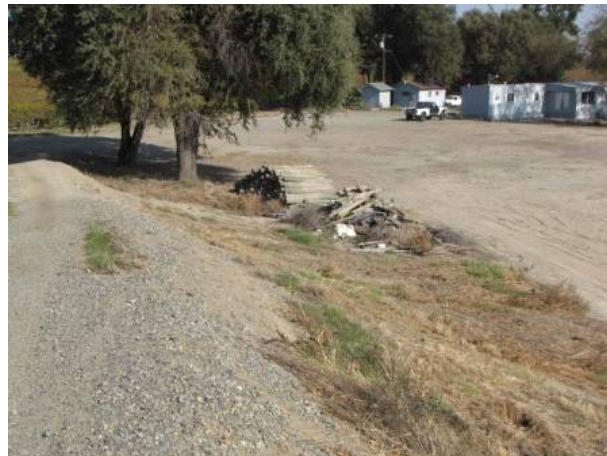
Levee Mile Report Line	34
Start Levee Mile	3.95
End Levee Mile	3.95
Location	Land Side
Category	Earthen Levee
Item	Encroachments

Updated view of material piled at the toe of the levee as of fall 2009.

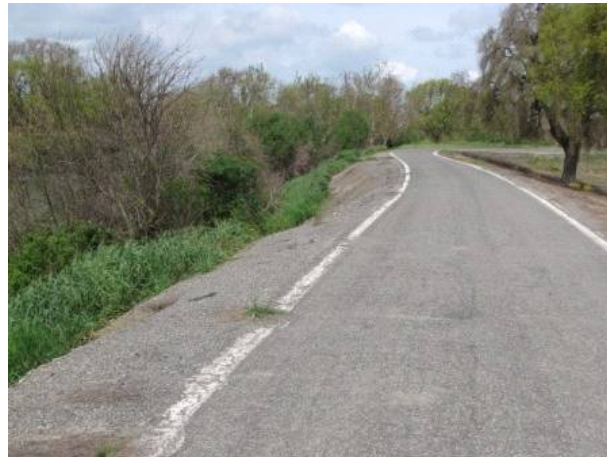
View of depressions in the roadway looking upstream.

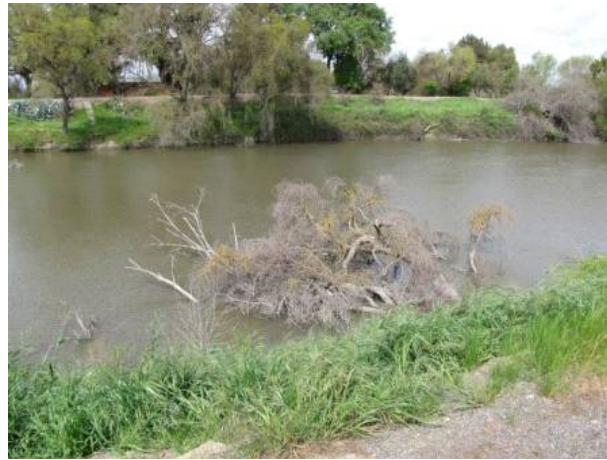
View of tree stumps on the waterward slope.

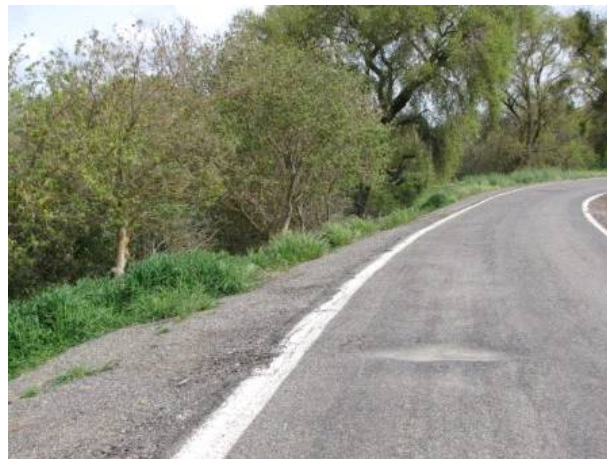
Levee Mile Report Line	40
Start Levee Mile	4.39
End Levee Mile	4.39
Location	Crown
Category	Earthen Levee
Item	Crown Surface / Depressions / Rutting

View of depressions in the crown roadway looking upstream.

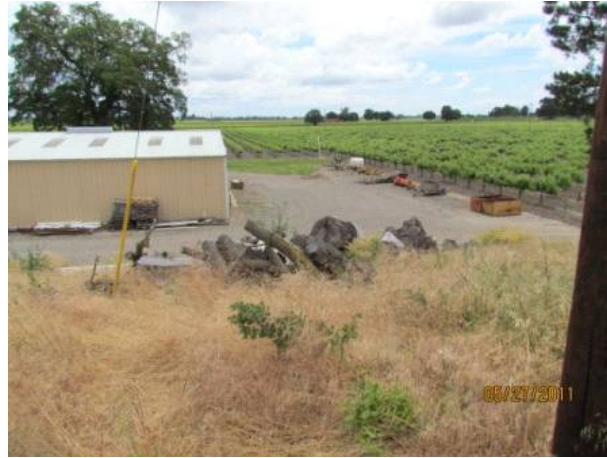
Tree branches were found on the toe of landside of the levee. The picture was taken from the crown looking downstream.

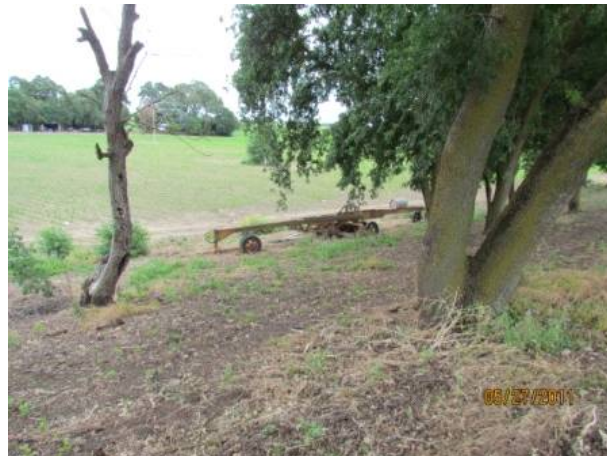
Levee Mile Report Line	45
Start Levee Mile	4.98
End Levee Mile	4.98
Location	Land Side
Category	Earthen Levee
Item	Encroachments

Equipment on the landside toe of the levee. The picture was taken from crown looking downstream.

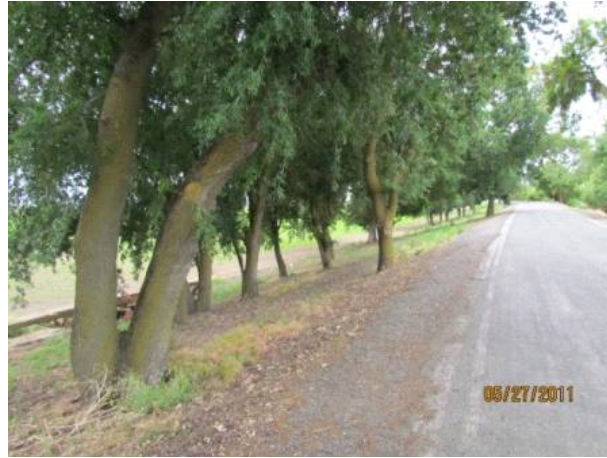
Trees were trimmed to see the visibility of the landward slope of the levee. The picture was taken from the crown looking downstream.

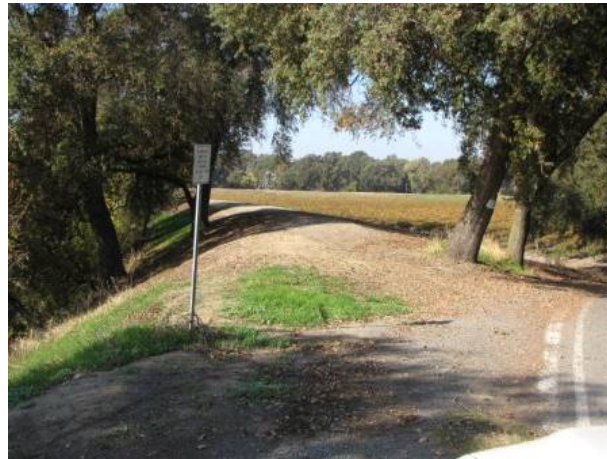
Levee Mile Report Line	48
Start Levee Mile	5.22
End Levee Mile	5.22
Location	Crown
Category	Earthen Levee
Item	Crown Surface / Depressions / Rutting

View of varying elevations in the crown of the levee at the transition from county road to access road.

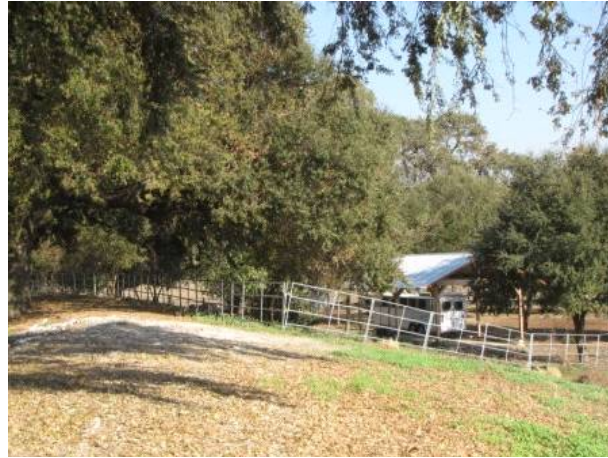
View of fence around a horse pen along the shoulder of the levee and the landward slope.

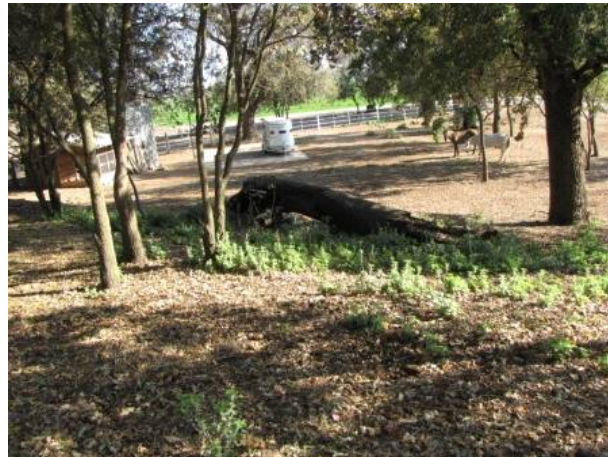
Levee Mile Report Line	52
Start Levee Mile	5.93
End Levee Mile	5.93
Location	Land Side
Category	Earthen Levee
Item	Encroachments

View of a tree trunk lying on the landward slope blocking visibility.

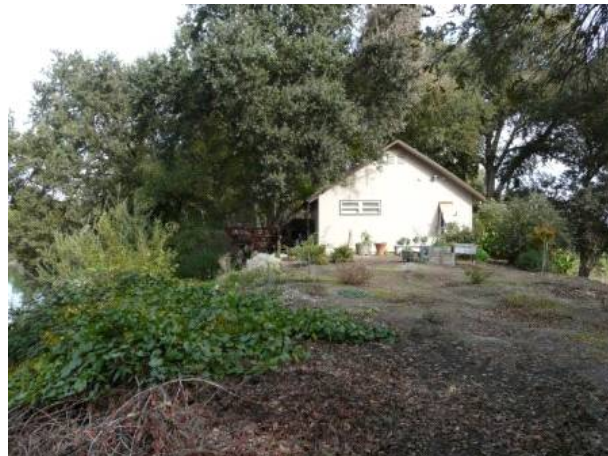
Levee Mile Report Line	53
Start Levee Mile	5.93
End Levee Mile	5.93
Location	Crown
Category	Earthen Levee
Item	Encroachments

Building & associated landscaping on levee crown at LM 5.93.

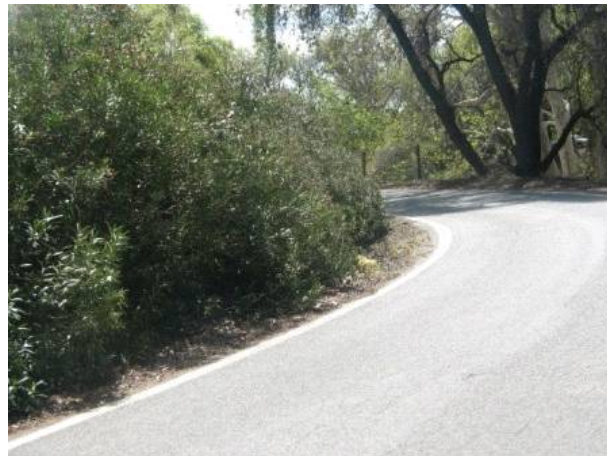
Levee Mile Report Line	57
Start Levee Mile	6.24
End Levee Mile	6.31
Location	Land Side
Category	Earthen Levee
Item	Encroachments
Oleander on landward slope blocking view of levee from LM 6.24 to 6.32	
pkazi_f_20110923_337.jpg

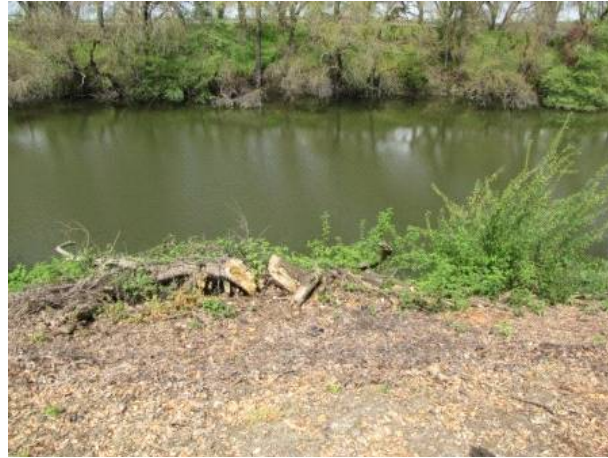
View of tree stumps on the waterward slope.

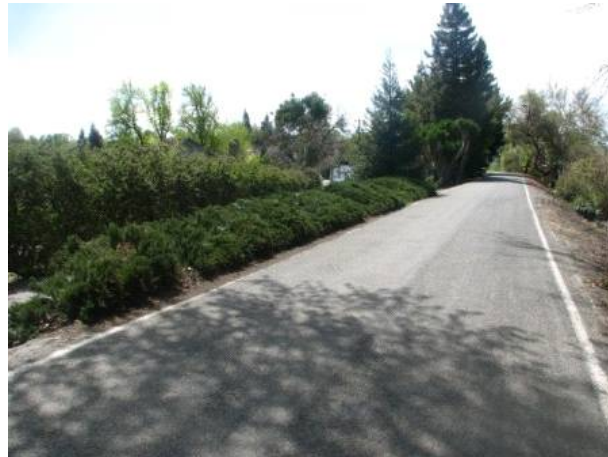
Levee Mile Report Line	60
Start Levee Mile	6.37
End Levee Mile	6.40
Location	Land Side
Category	Earthen Levee
Item	Encroachments

Landscaping on landward slope blocking view from LM 6.37 to 6.40

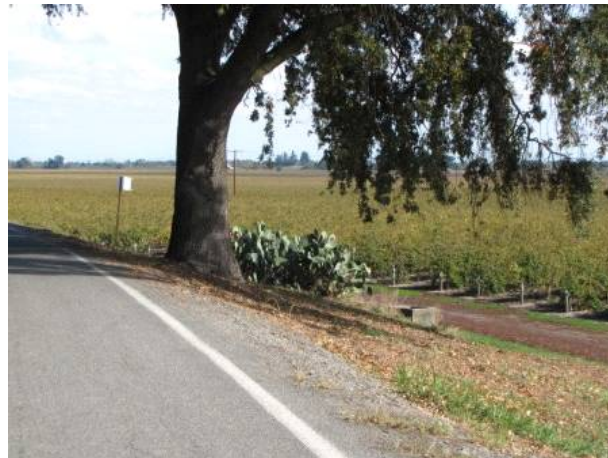
Levee Mile Report Line	61
Start Levee Mile	6.56
End Levee Mile	6.56
Location	Land Side
Category	Earthen Levee
Item	Encroachments

View of landscaping along the landward slope.
